SITE SCREENING ASSESSMENT

Date: 04/23/2014

Site Name:	Pacific Alternators				
City:	Bell		County:	Los Angeles	
DTSC Regional Office:	Cypress				
CERCLIS ID:	CAN000900126	EPA ID: CAD982314106		Envirostor ID:	60001975

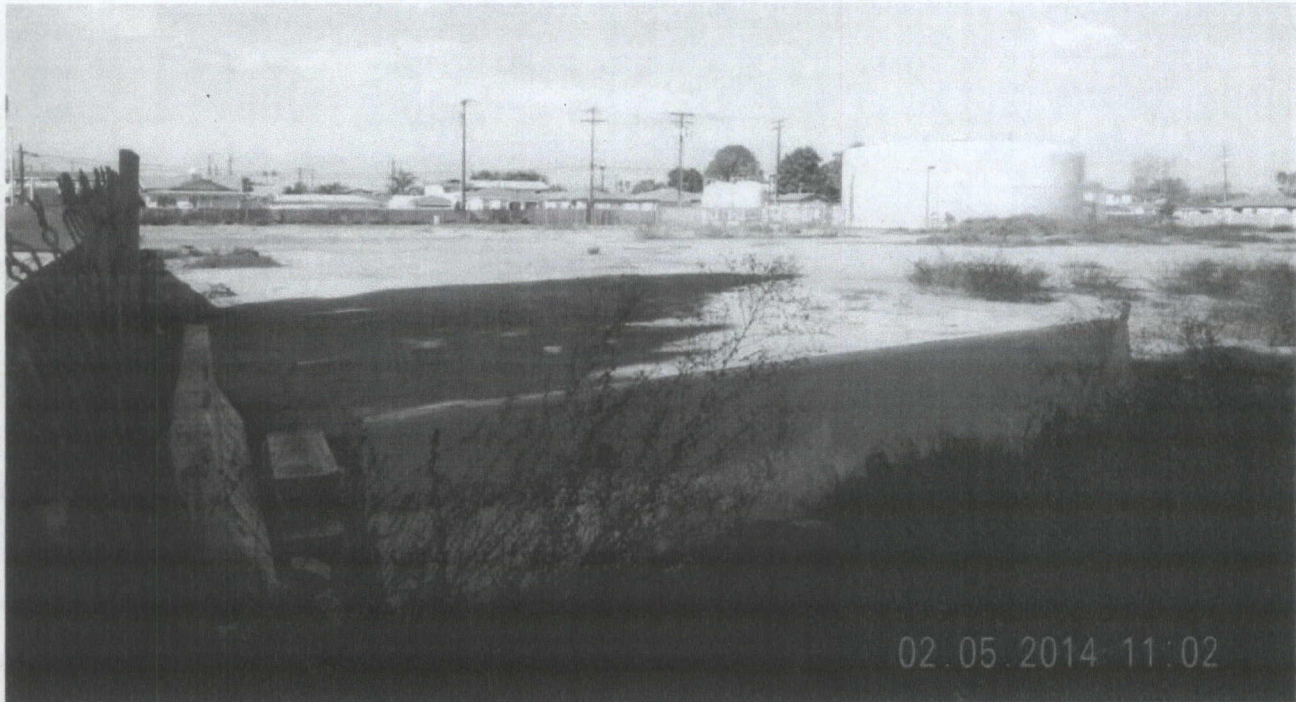
View to the northwest across the southern portion of the former Pacific Alternators property. The adjacent drinking water well (Watson Well 01) infrastructure is located in the background.

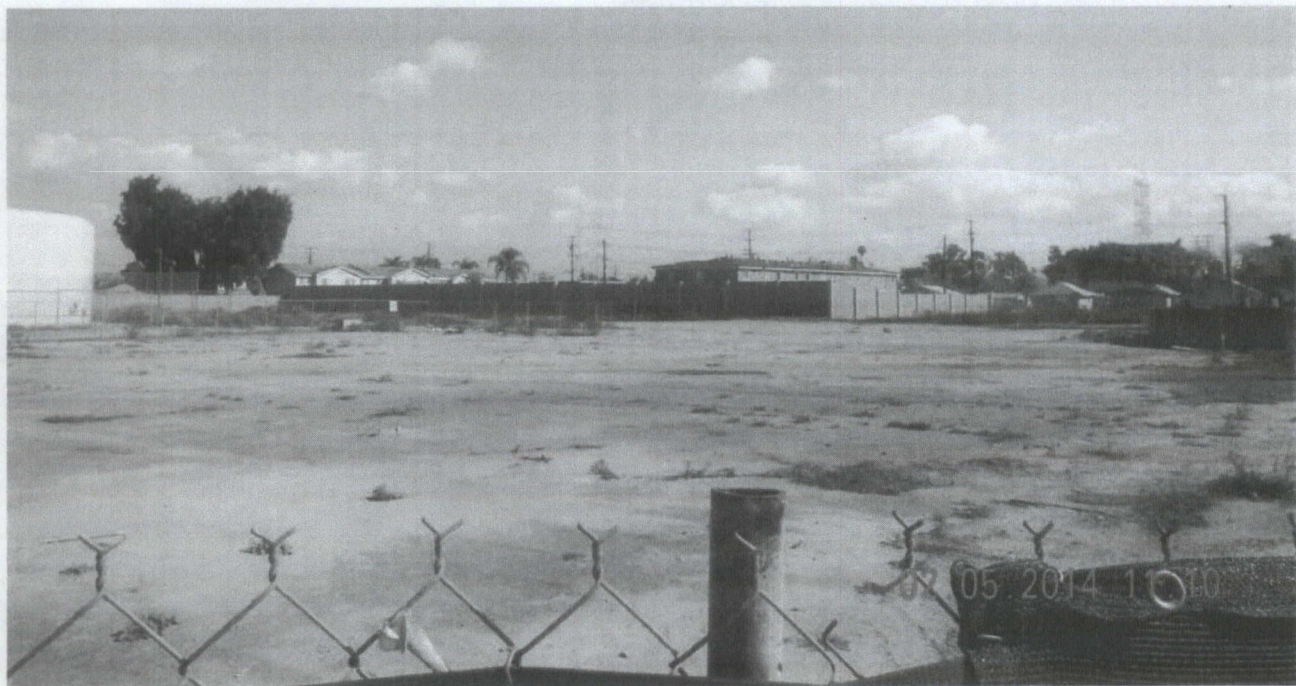
4.4 Site surface description (e.g., visual staining, cracked pavement, etc.): Vacant lot
with no visual staining and some cracked pavement.

View to the northeast across vacant (but paved) portion of property.

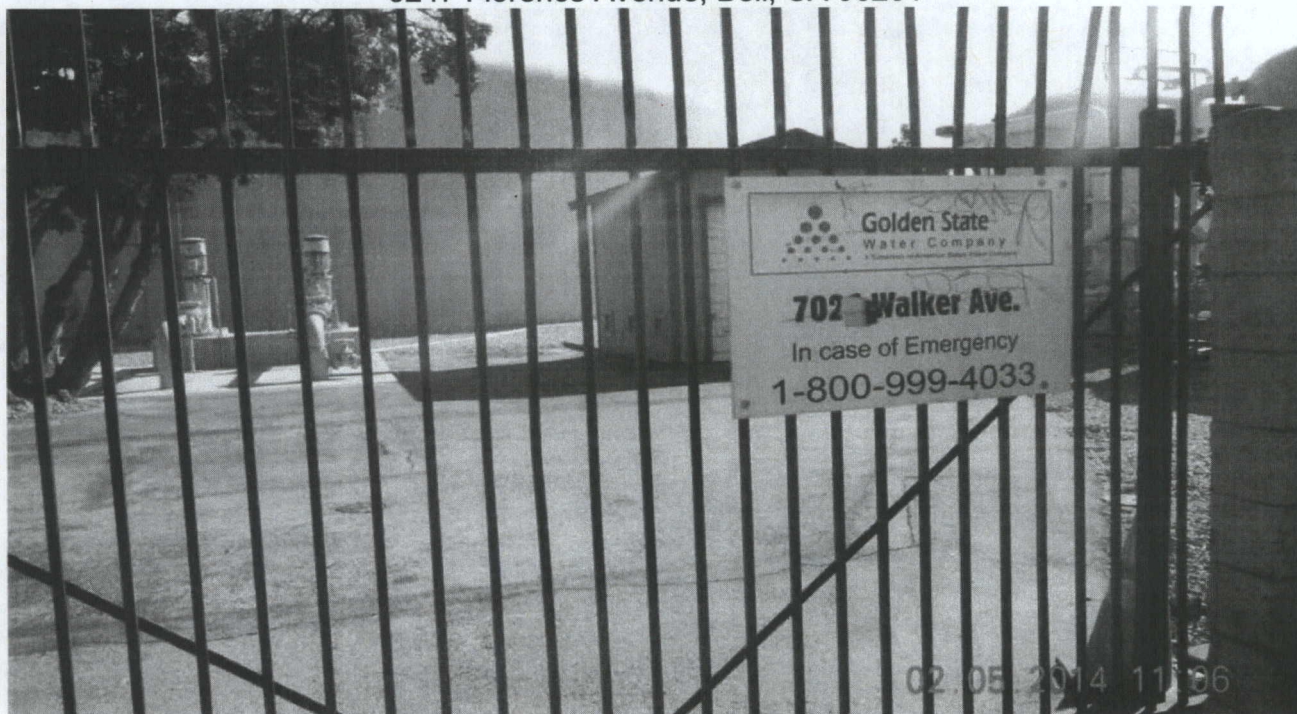
View to the east of the adjacent drinking water well property.

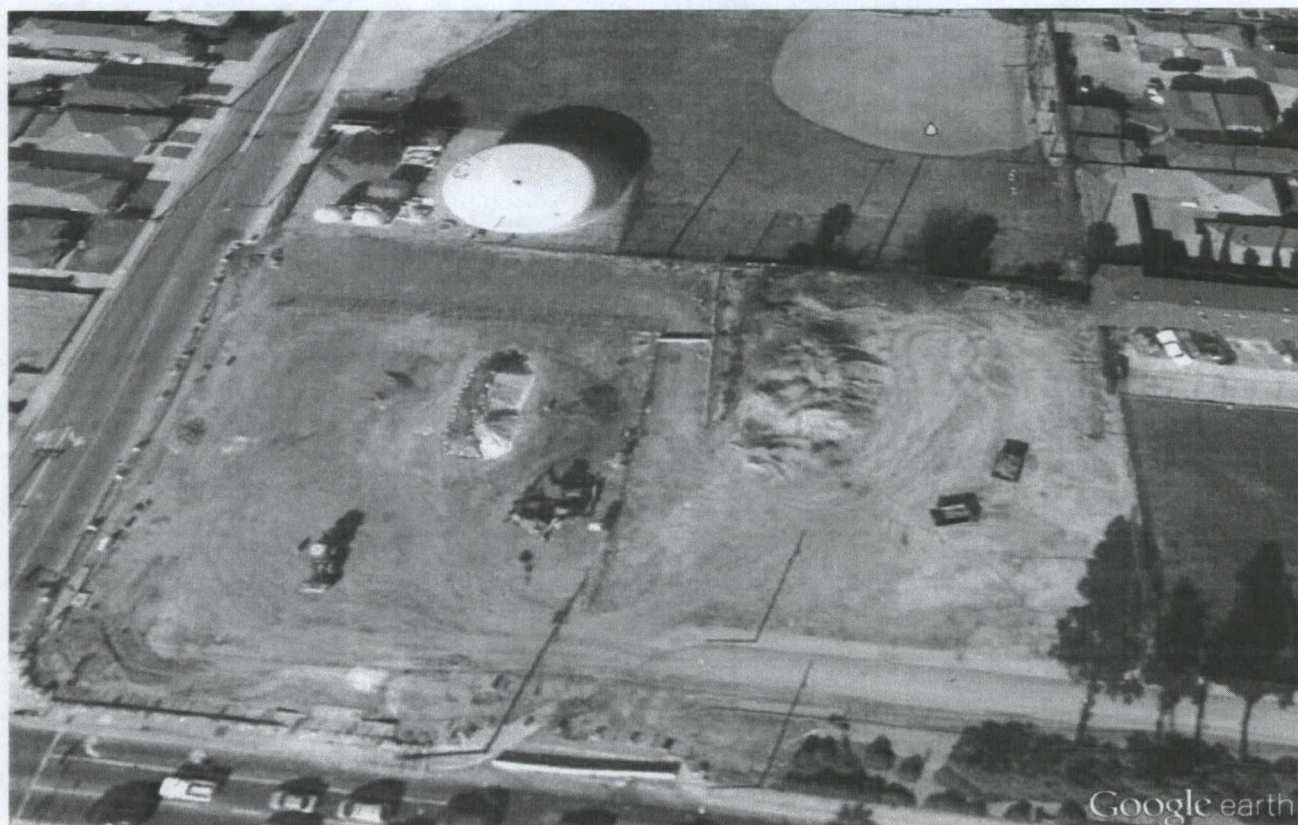
Google Earth image from November 14, 2009 potentially depicting remediation work onsite.

Based on GIS data information, there is a PCE and TCE impacted production well on the adjacent property approximately 50 feet from the site. At the closure of the business in 2005, PCE and TCE exceeded MCLs, however impacts have reduced to below MCLs for TCE and PCE, to date. It is unknown if any site remediation took place after closure of the facility. A Google Earth image from November 14, 2009 showed some site work potentially depicting remediation work onsite but the nature of the work is currently unknown (See Attachment B photos).

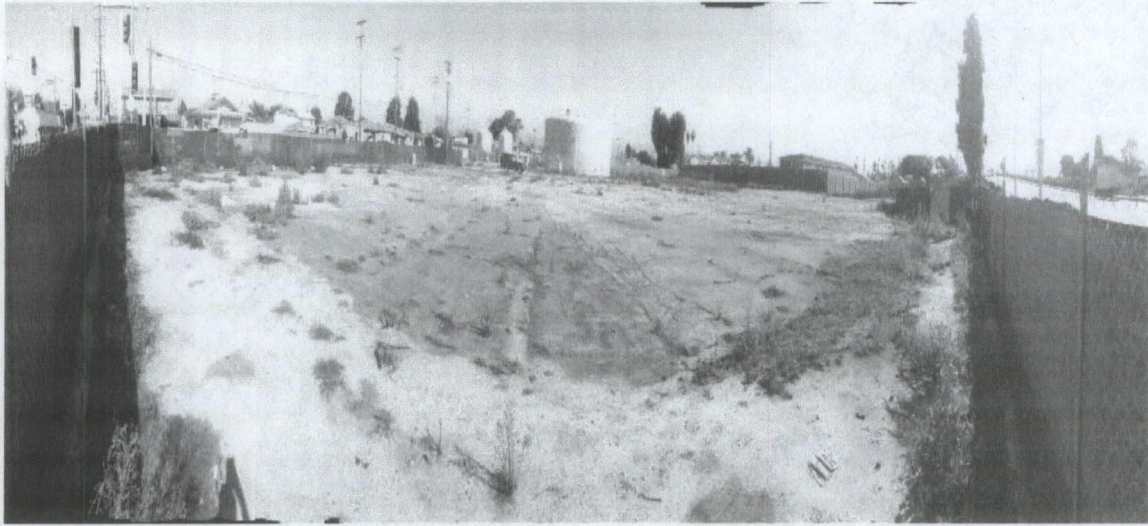
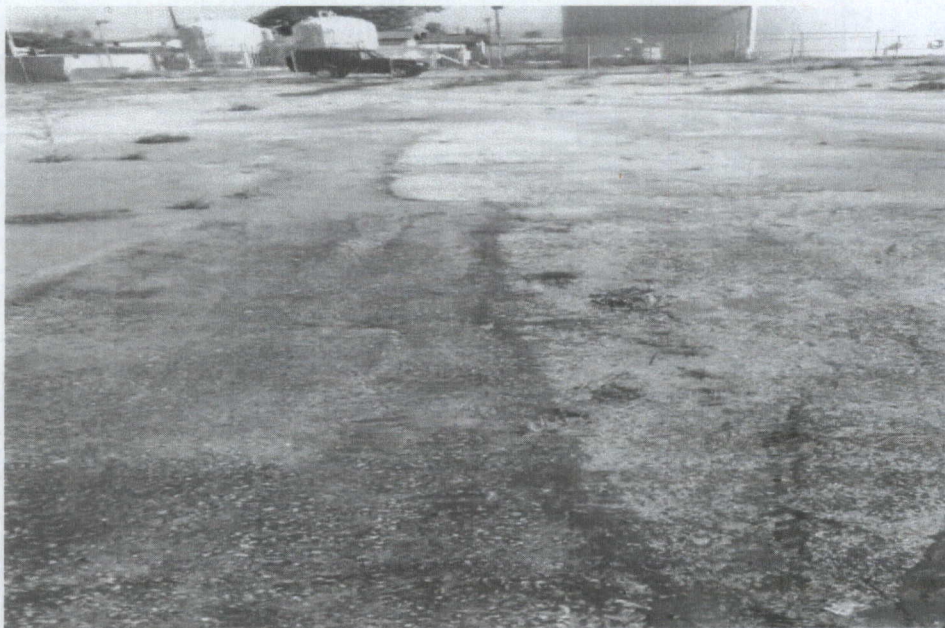
Looking Toward North

Currently the site is a vacant lot when visited on 3/13/2014, with no visible discoloration on its asphalt or visible solid or liquid materials or wastes at the site. Even though the site lies within a high priority SPGIT area (80), there is no indication from the file review and site visit that the site has had an accidental release to soil or groundwater during its operations. However, due to the previously impacted production well with PCE and TCE, and because the site utilized PCE based on HWTS data, further environmental investigation by EPA is recommended to determine if this site is a source of PCE and TCE contamination in groundwater.
